IMAGE ARTICLE

An Echocardiographic Image of a Massive RV Thrombus that Led to Circulatory Collapse in a Patient with COVID Pneumonitis

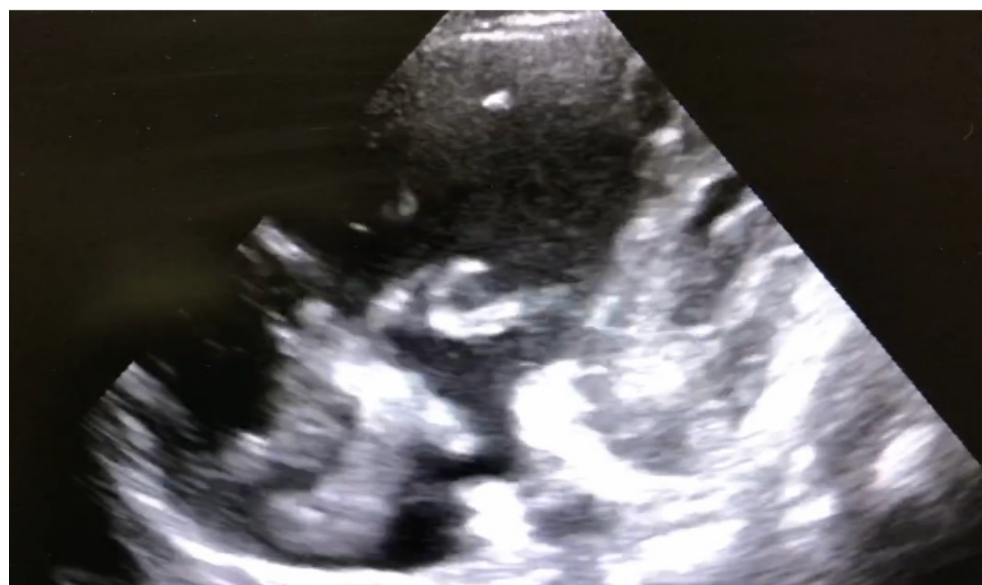
Figure 1: Echocardiography.

The patient was hemodynamically stable and required high flow oxygen therapy for 72 hours. He had a sudden hemodynamic collapse whilst receiving high flow oxygen therapy. An ICU registrar performed a bedside echocardiography (Figure 1) that revealed

a large volume blood clot occupying the Right Ventricular (RV) inlet. There was also ECHO evidence of Dilated RV; Dilated Right Atrium and RV pressure overload with a completely obliterated LV cavity.
