CASE REPORT

Shaft Rupture of Ultra-High Pressure Balloons

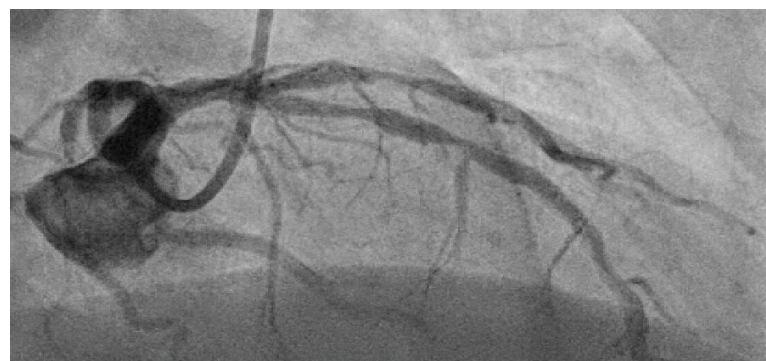
Figure 1: Right anterior oblique cranial projection showing suboptimally expanded stents in the proximal LAD.

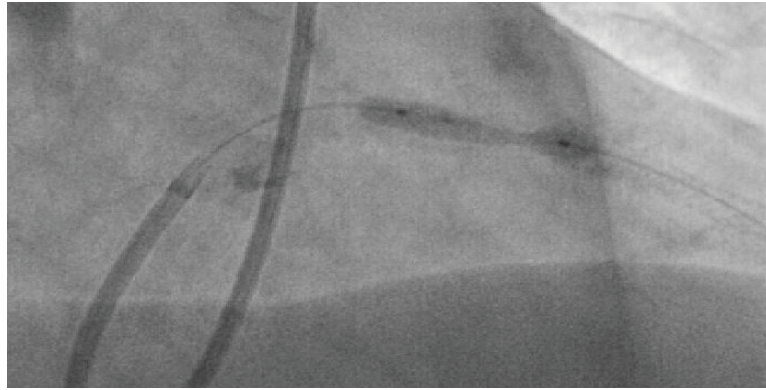
Figure 2: “Dog-boning” of ultra-high pressure balloon inflated inside the stent at 35 atm.

The first patient, a 65-year-old male, presented to our emergency department with unstable angina without troponin elevation for the first time in January 2015. A calcified culprit lesion in the Right Coronary Artery (RCA) was managed by stenting. Staged Percutaneous Coronary Intervention (PCI) of a significant proximal stenosis of the Left Anterior Descending (LAD) was scheduled for March 2015. During this procedure, two drug-eluting stents were implanted in a highly calcified and tight stenosis of the LAD (Figure 1). Significant residual stenosis was observed, which could not be resolved by high-pressure angioplasty at 26 atm with a non-compliant balloon catheter, or even at 35 atm with an ultra-high pressure balloon (OPN NC balloon, SIS

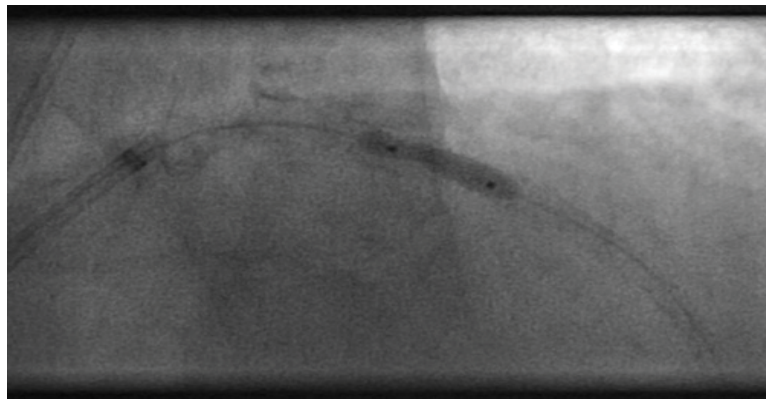
Figure 3: Ultra-high pressure balloon that remains inflated even after pressure-drop in the inflator, indicating rupture. Balloon is still underexpanded in the proximal part.

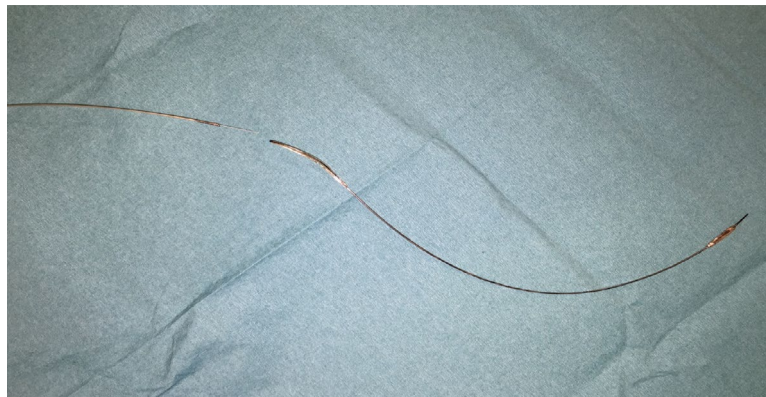
Figure 4: Ruptured balloon after successful removal.

inflated balloon from the coronary artery, the proximal shaft completely detached from the distal part at the rupture site (Figure 4 and Figure 5). An attempt to puncture the inflated balloon inside the LAD with the stiff end of a coronary wire that was advanced through a microcatheter failed. Removal of the detached and still partially inflated balloon from the calcified lesion was eventually achieved by “jailing” the remaining balloon shaft in the guiding catheter with another balloon inflated at high pressure inside the guide and then carefully retracting the catheter together with the balloon (Video 1). Total ischemia time until successful retrieval was 30 min. Patient recovery was uneventful and without residual wall motion abnormalities at discharge, although the complication led to a significant increase in necrosis markers and stent deployment was still sub-optimal.

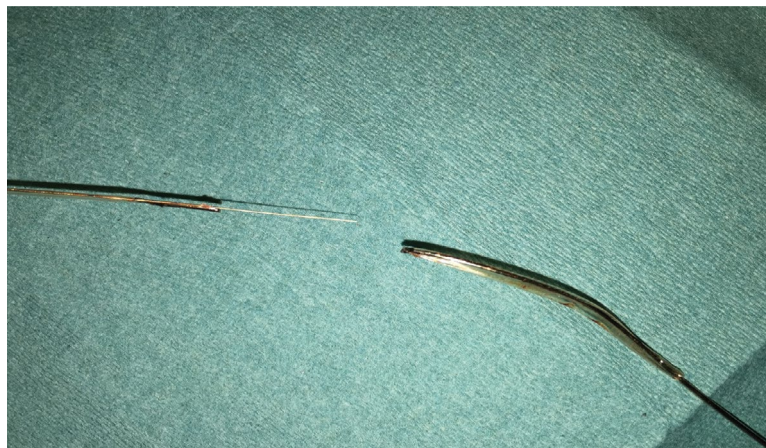
Figure 5: Closeup of the site of rupture and detachment.

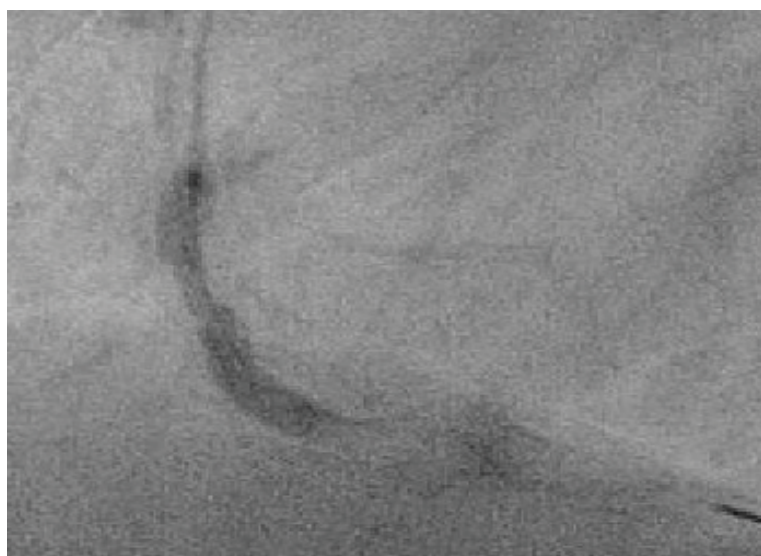
Figure 6: “Dog-boning” of ultra-high pressure balloon in RCA at 35 atm in patient 2.

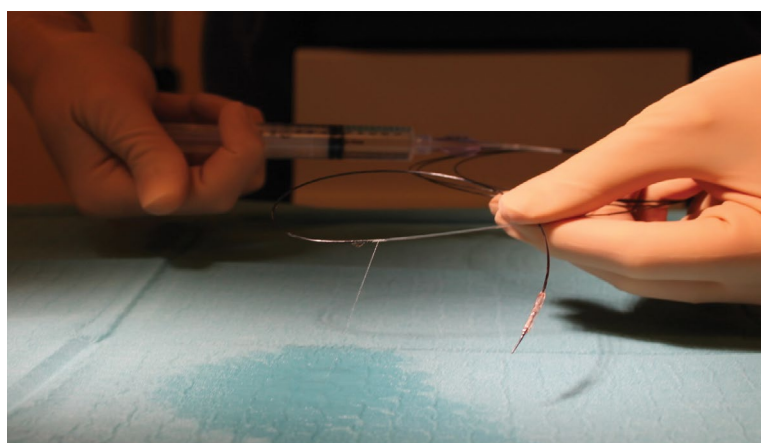
Figure 7: Flushing with saline indicates site of rupture in balloon catheter from case 2.
