## CASE REPORT

# Losing Jacket of Guide Wire - A Rare Intraoperative Complication of Percutaneous Nephrolithotomy - Method to Identify and Safely Remove it

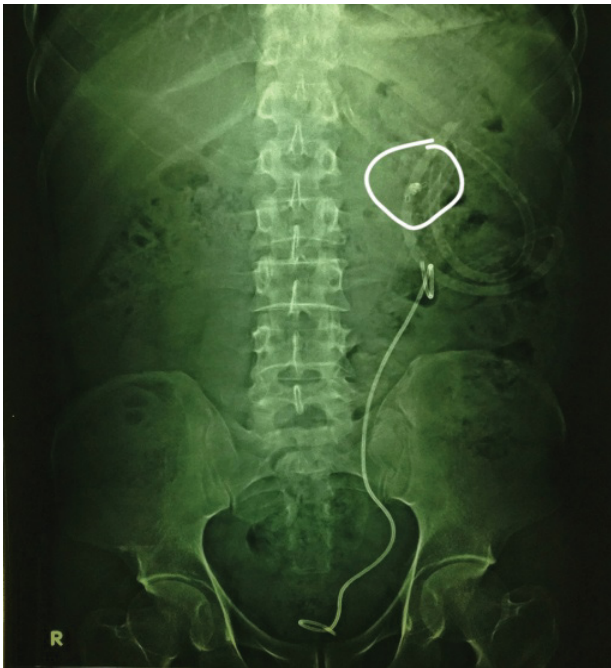
**Figure 1:** X-ray KUB showing coiled stripped glide wire fragment (white circle).

puncture needle in place. During removal the jacket of the glide wire got stripped and lost into the renal parenchyma. Another calyceal puncture was made and tract dilated and stone was removed. There was no endoscopic trace of the stripped glide wire in the PCS, though it was visible in fluoroscopy. Every calyx was searched but the stripped wire could not be seen. A DJ stent and nephrostomy tube was placed and procedure abandoned. Postoperative X-ray was showing the stripped glide wire coiled in the renal area (Figure 1). After two days patient was again taken to Operation Theater after proper planning to remove the residual glide wire. Under fluoroscopic guidance the puncture was made directly on the stripped wire (Figure 2). A new glide wire was into the PCS under fluoroscopic guidance. Tract was dilated to 12 Fr and 8.5 Fr ureteroscope was passed through the sheath. The stripped wire was identified (Figure 3) and removed intact (Figure 4). Postoperative period was uneventful.

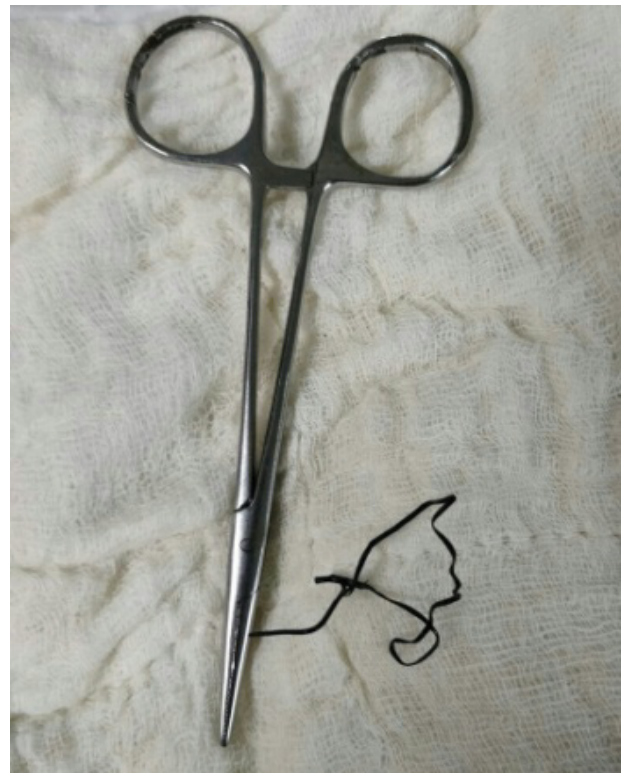
**Figure 4:** Glide wire jacket removed intact.

The Terumo hydrophilic Glide wire we use consists of super-elastic nitinol alloy core for optimal performance and kink resistance. Tungsten-infused polyurethane jacket provides superior tip and wire radiopacity [4]. When coiled guide wire is pulled forcibly the jacket may get stripped from the nitinol core by the edge of the puncture needle. Attempts to localize the stripped glide wire failed endoscopically since the fragment was lost in the renal parenchyma. Such a fragment may even be difficult to identify in open surgery. Already exhausted by the attempts to identify the lost glide wire and prolonged operative time, procedure was abandoned

with the aim of coming back after proper planning. The stripped glide wire was targeted under fluoroscopic guidance and small tract was carefully dilated up to the coiled jacket and removed intact under vision.
