Treatment Approach in Teeth with Complicated Crown and Crown-Root Fracture: Three Case Reports

Abstract

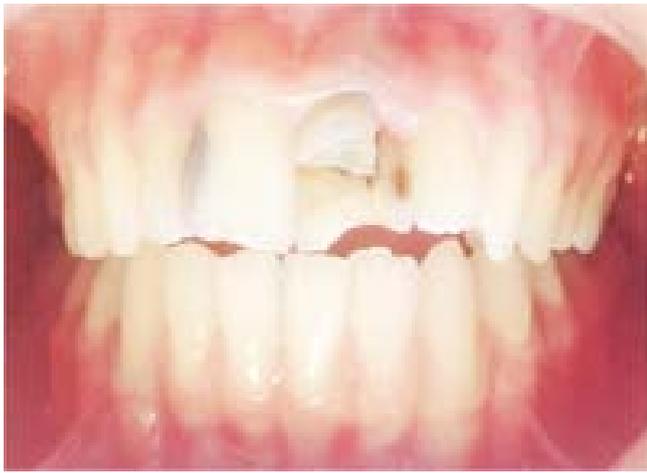
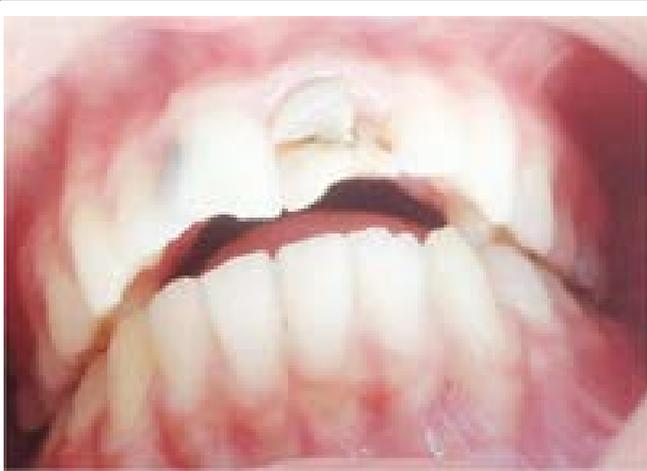
Figure 1: The vestibule view Figure.

Figure 2: The incisal view of 21 numbered tooth.

University Faculty of Dentistry Department of Pediatric Dentistry with fracture at 21 numbered tooth as a result of hitting to a hard object while playing at park. It has been learned from the anamnesis that, 4 years ago root-canal treatment was performed to the same tooth following a trauma. Following the clinical and radiological examinations, a fracture was diagnosed which starts from the crown and proceed to the root (Figure 1-4).

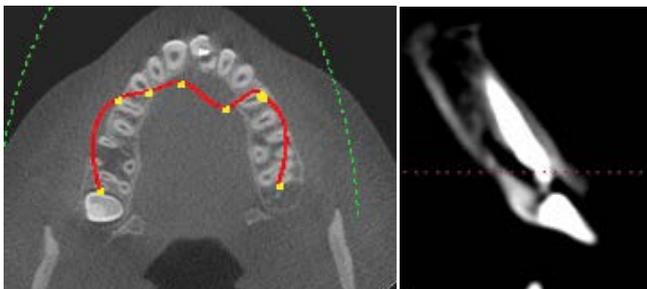
Figure 3: The cone beam computed tomography view of 21 numbered tooth.

Cone beam computed tomography was taken from the patient for the certain diagnosis after receiving approval from the parent. As a result of the evaluation of the tomographic views, an oblique fracture was diagnosed which starts from the crown and proceed until the midline of the root (Figure 3). The patient and the family were informed about the treatment options and the approval received from the family. First of all, before the post-core restoration Immgingiva tissue was removed from the vestibule part of 21 numbered tooth by 15 numbered scalpel (Shandong Sinorgmed Co., Ltd. Shandong, P.R.C). Thus, the gingival level of two upper central incisors regulated symmetric. Following session, the 2/3 part of gutta-percha was removed from the root canal by a drill (snowpost-16,carbotec, Ganges, France) in order to place the post material. The inside of the canal and the enamel-dentin tissues of the tooth etched by 37% phosphoric acid (3M Scotchobond; 3M ESPE, St. Paul, Minn, ABD) 15 seconds. Following the etching procedure, tooth was rinsed with water in order to remove the acid. The primer and bond of self-etching adhesive (Clearfil SE Bond, Primer; Kuraray Co. Ltd, Osaka, Japan) was applied to the tooth. Than the A and B parts

CBCT. Some materials as gutta-percha, canal filling paste, and posts may cause artefacts. But, while diagnosing a root fracture, clinical and radiologic findings and symptoms must be evaluated together [15]. In case 1 because of the gutta-percha superposition, the fracture line could not be determined clearly. That is why it was evaluated with taking 3D views by CBCT.

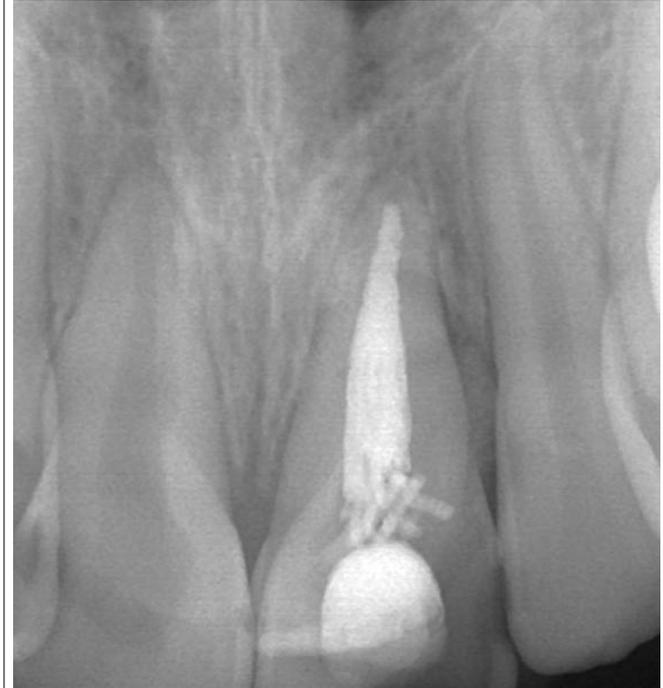
Figure 4: The periapical radiography of 21 numbered tooth.

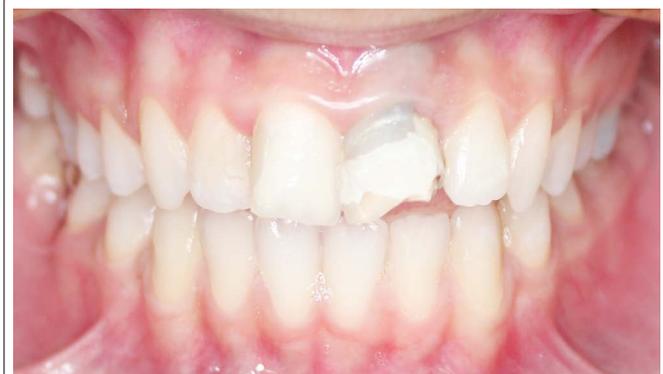
Figure 5: The view of 21 numbered tooth following fiber post application.

of dual-cure adhesive material (Panavia F, Kuraray Co Ltd, Osaka, Japan) were taken equally and mixed 20 seconds. Then it was applied into the canal with a lentulo (Mani Inc, Tochigi-Ken, Japan) The glass fiber post (snowpost-16, carbotec, Ganges, France) was covered with the adhesive material and was placed with finger pressure. The light (Curing Light XL 3000; 3M, St Paul, MN, ABD) was performed 40 seconds for the polymerization of dual cure adhesive. The polymerization was completed with performing Oxyguard II gel (Kuraray, Osaka, Japan) 3 minutes. The long coronal part of fiber post was removed and the restoration was completed with hybrid composite resin (Clearfil AP-X, Kuraray, Osaka, Japan) (Figure 5). After the post application, periapical radiography was taken from the 21 numbered tooth (Figure 6).

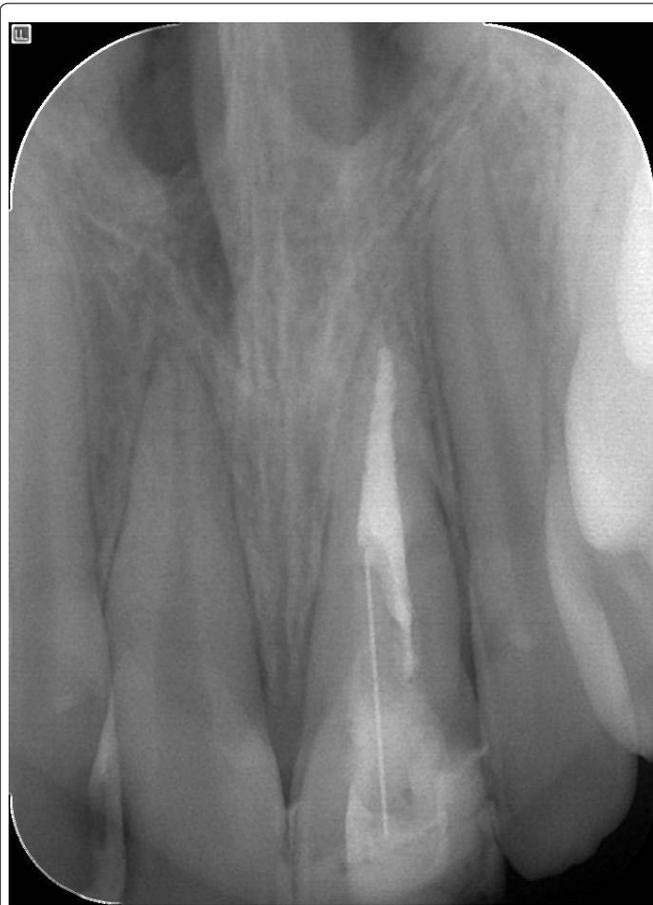
Figure 6: The periapical radiography of 21 numbered tooth following fiber post application.

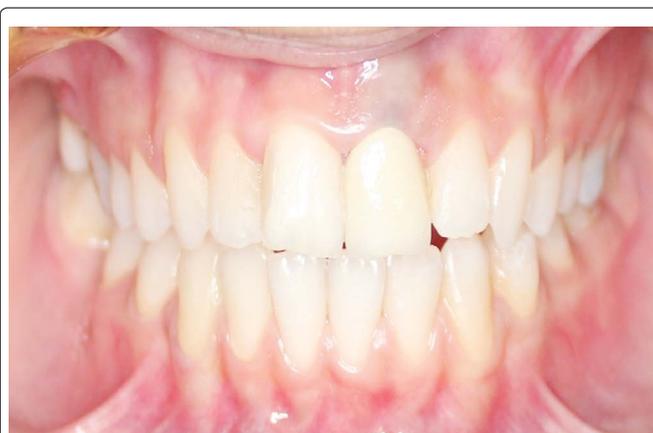
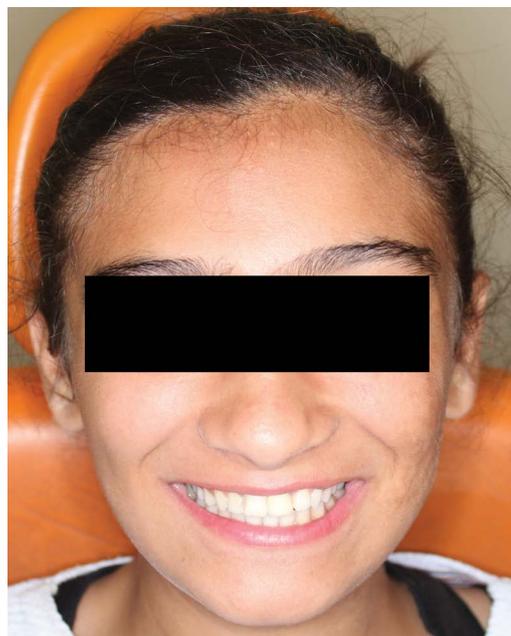
Figure 7: Intraoral view after the treatment.

Figure 8: The view of patient after treatment.

impression, retraction cord (Stay-put, Medium; Roeko, Langenau, Germany) was used in order to decrease gingival fluid and then a type silicon impression material was used for impression (A-Silicone Elite HD+, Zhermack, Rovigo, Italy). In order to enhance the aesthetic view, laser sintering method was performed to the metal substructure of prosthesis. Before the colour decision, polishing was performed to the anterior teeth of patient. The colour decision was performed with the traditional technique by vita 3D Master (Vita Zahnfabrik, Bad Säckingen, Germany) colour scale. After the ceramic restoration prepared, it was cemented, restorations were cemented with zinc-polycarboxylate cement (Adhesor Carbofine Zinc polycarboxylate cement, Spofa Dental, Jicin, Czech Republic) (Figure 7 and Figure 8). The patient was advised to come every 6 months for the control sessions. After the 2 years control period there were not any clinical and radiological problems (Figure 9).

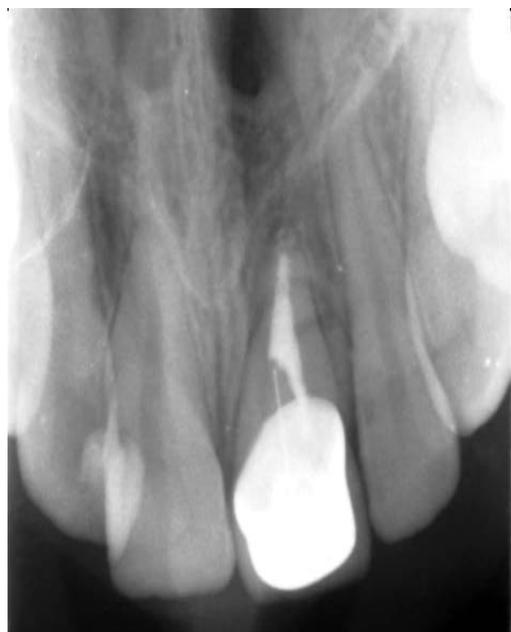
Figure 9: The radiographic view after 2 years.

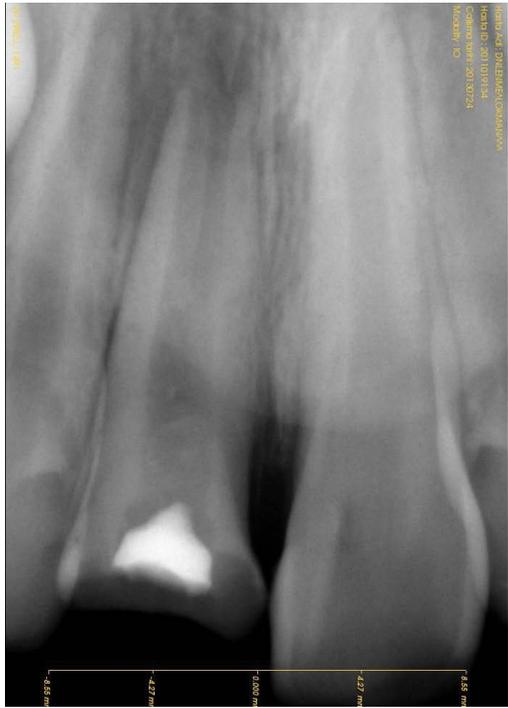
Figure 10: The radiographic view of 11 numbered tooth.

with fracture at 11 numbered tooth as a result of hitting to a hard object while playing at park (Figure 10).

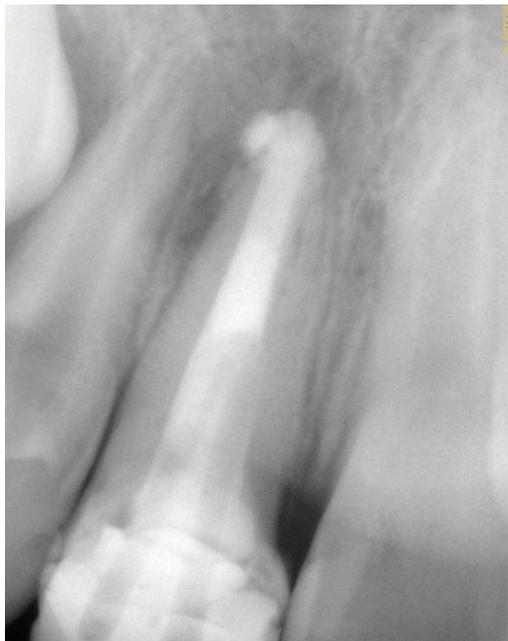
Figure 11: The radiographic view of 11 numbered tooth following fiber post placement.

Following the root-canal treatment the same treatment procedure in case 1 was followed and the restoration was completed (Figure 11-14). We placed mineral trioxide aggregate (MTA) in large-open apices before the root canal treatment. But, the patient was pained after root-canal treatment. For this reason, we were performed apical resection. The patient was advised to come every 6 months for the control sessions. The radiographic examinations after 6 and 24 months did not show any pathological symptoms (Figure 15). The clinical examination also did not show any pathological symptoms.

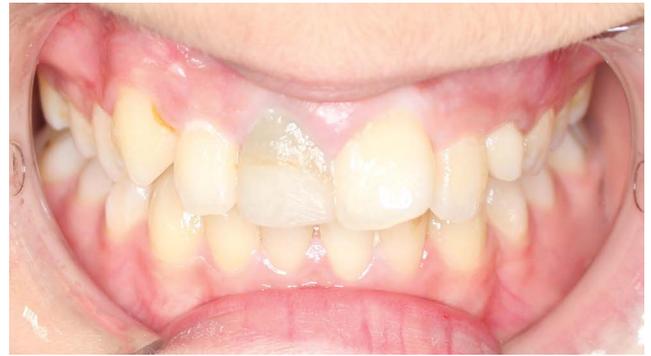
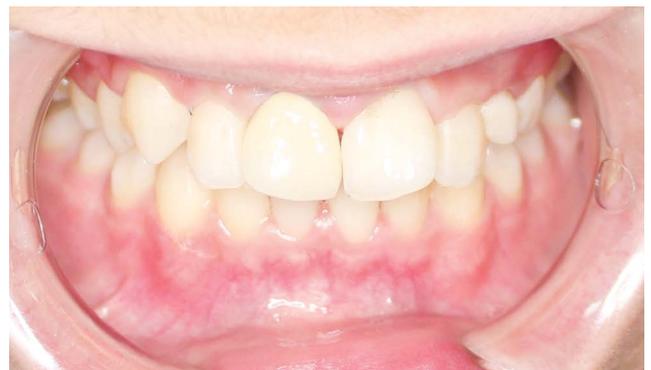
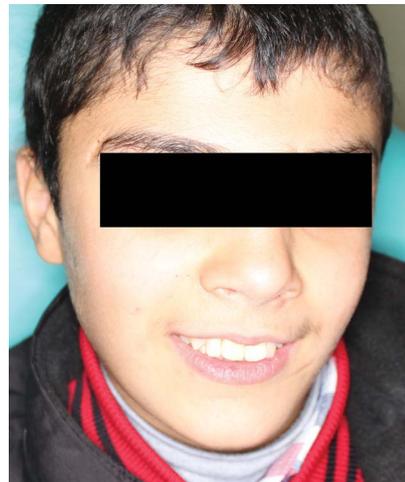
Figure 12: The intraoral view of 11 numbered tooth following fiber post application.

Figure 13: Intraoral view of patient after the treatment.

Figure 14: The view of patient after treatment.

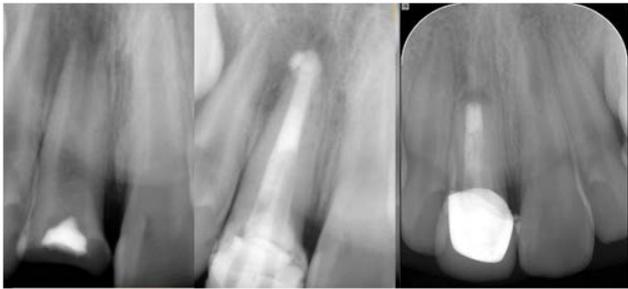
Figure 15: The view of periapical lesion healing at 6th and 24th months.

Currently, MTA is believed by many authors as the material of choice for apical plug in cases of necrotic pulp and large-open apices. One of the major aims is its well sealing ability. But, the extrusion of this material to the periapical tissue can prevent with the repair process. Moreover, this substance has a high cost and to have difficulty applying the apical region, including the risk of extrusion to the periapical tissues, which could give rise to tissue injury and harm to the repair process [28]. If root canal therapy fails, endodontic surgery may be required. Endodontic surgery involves a combination of curettage of infected tissue and removal of an infected or damaged root apex [29]. Because of these, we were performed apical resection for our second case.

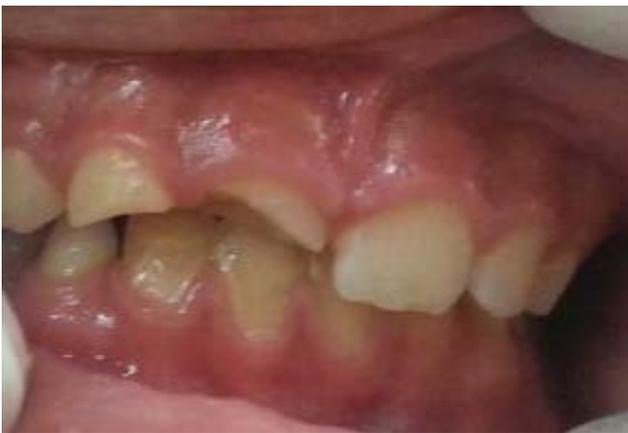
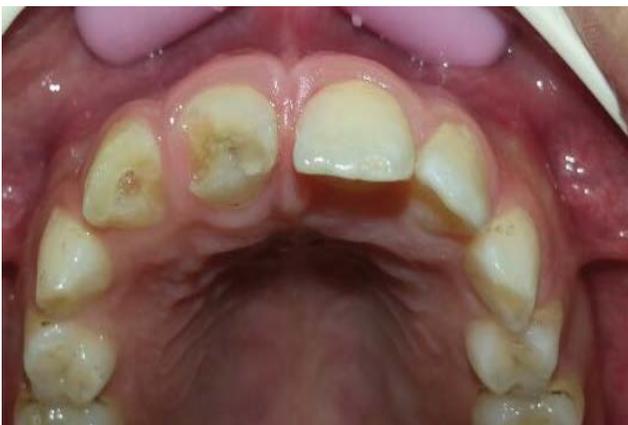
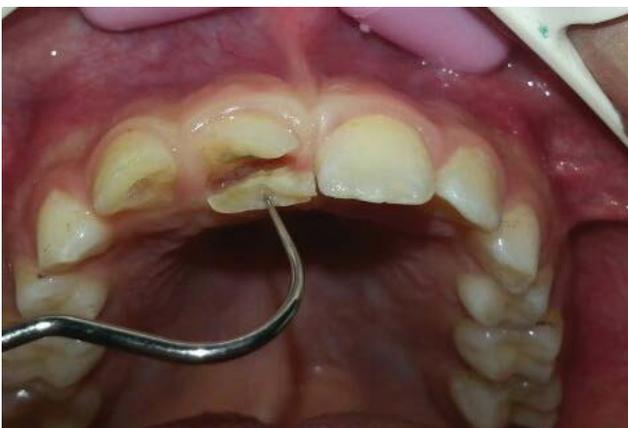
been applied to our clinic with the reason of fracture at upper right incisor. In anamnesis, any systemically disease was not determined and while questioning the trauma history, it was learned that the patient felt from the swing a month ago. In intraoral examination, complicated crown fracture which extends below the gingiva was observed (Figure 16-18). In radiographic examination, it's observed that the apex of the tooth is open (Figure 19). In clinical examination, any sensitivity at percussion or palpation was not observed and the reaction to electrical vitality test was negative. Apexification with Frank method was performed at the same day because of open apex. After the endodontic access cavity, canal preparation was performed with H-files. After each preparation, The root canal was irrigated by 5,25% sodium hypochlorite between each file change and final irrigation was performed by saline solution. Sterile paper points were used to dry root canal. Calcium hydroxide pasted (Sultan, USA) was applied to the root canal and glass ionomer cement (Fuji 9, Japan) was used as temporary filling material. The patient recalled after 3 weeks.

Figure 16: The vestibule view.

Figure 17: The incisal view of fracture at upper right incisor.

Figure 18: The incisal view of fracture part of tooth.

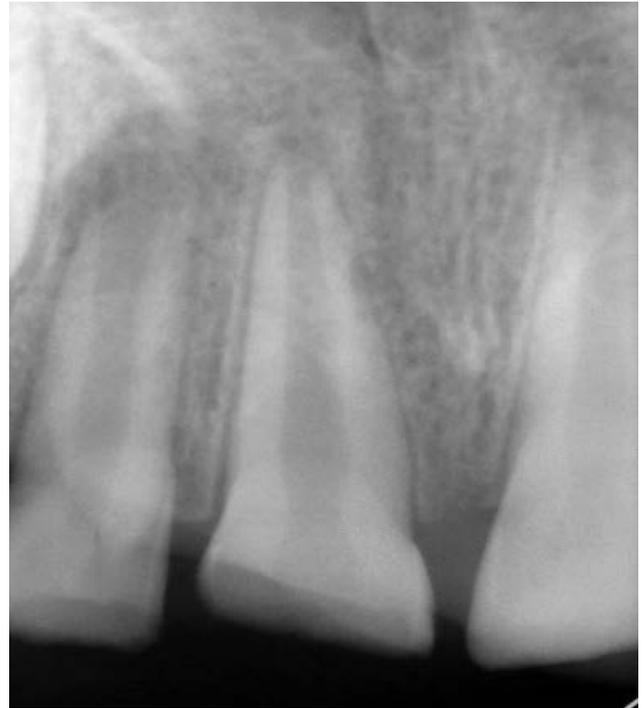
Figure 19: The radiographic view.

Same procedures were repeated at second session. In radiographic examination which practiced after 2 months, apex was closed. At the

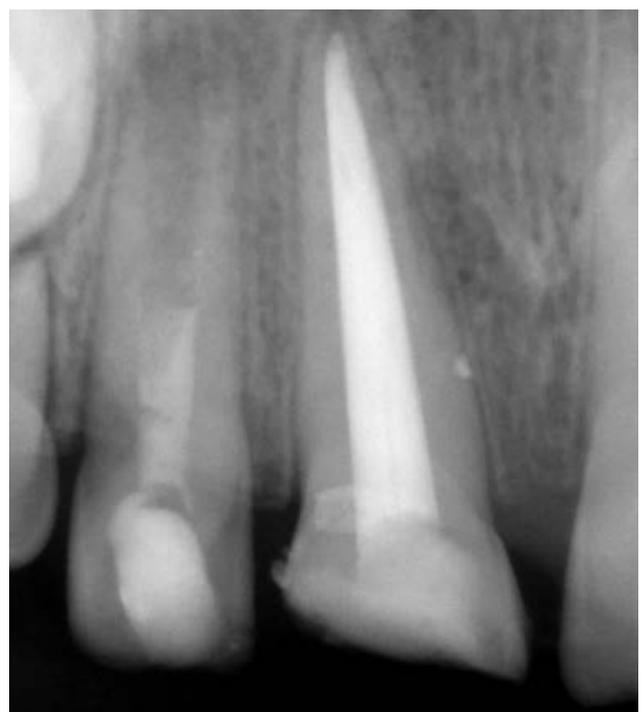
Figure 20: The radiographic view after endodontic treatment.

same session, root canal was filled with AH Plus (Dentsply, Germany) and gutta-percha (Diadent, Korea) by lateral compaction technique (Figure 20). The patient was recalled after a week.

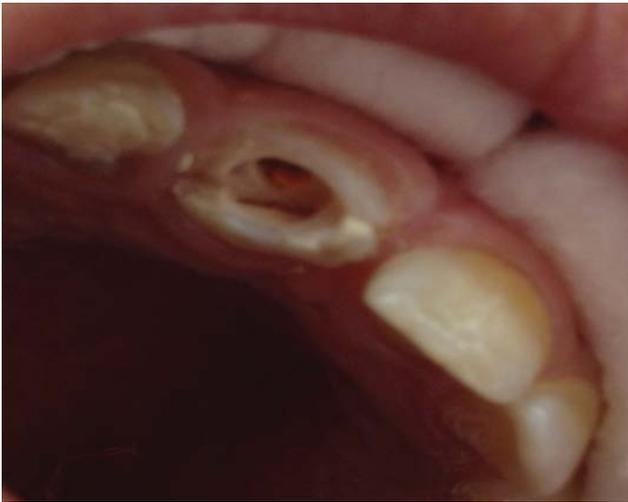
Figure 21: The view of preparing post.

After that, the coronal 2/3 part of root canal filling material was emptied in order to place post by drills of the post system (Figure 21). Inside of the canal and enamel-dentin parts of the tooth were etched with 37% orthophosphoric acid (3M ESPE) and cleaned. Fiber post was placed into the root canal with adhesive resin cement and was polymerization 30 seconds by light device (Figure 22). Then the long part of fiber post was cut and restoration was performed with resin composite (Filtex Supreme 3M ESPE USA). Polishing procedure was performed with polishing discs (Figure 23-25).

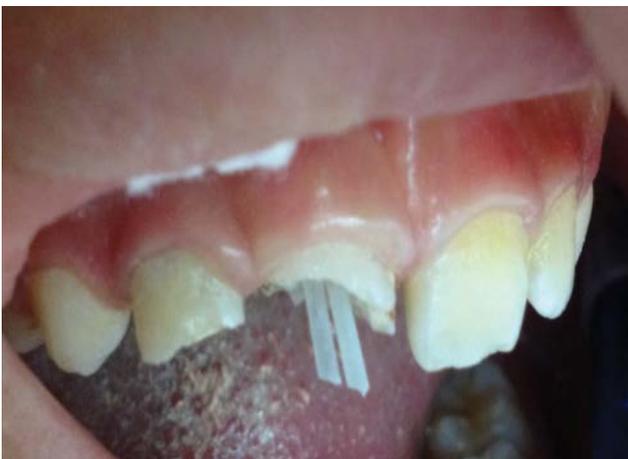
Figure 22: The view of after fiber post application.

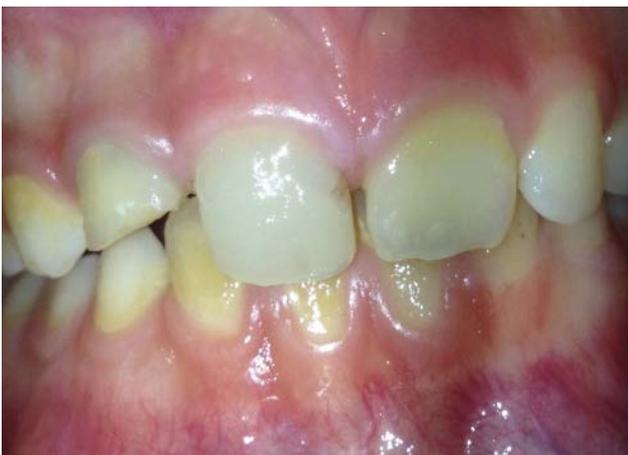
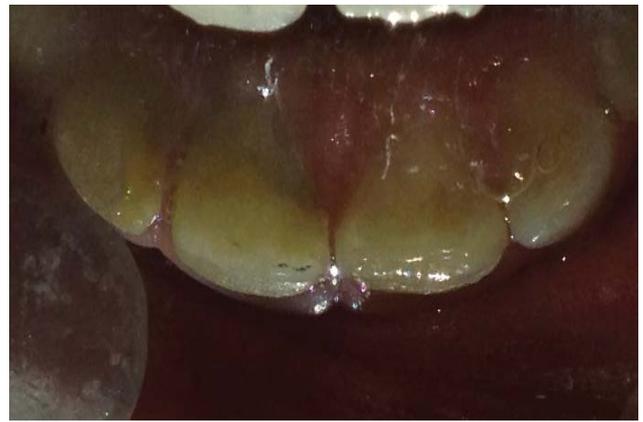
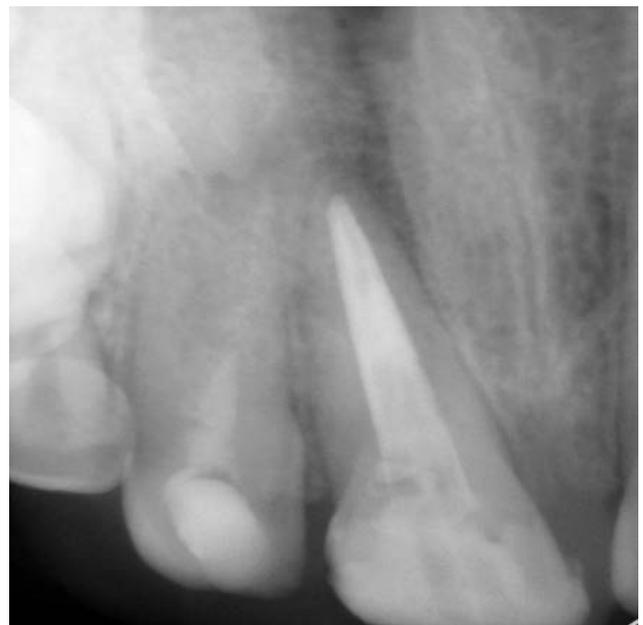
Figure 23: The vestibule view after the treatment.

Figure 24: The incisal view of tooth after the treatment.

Figure 25: The radiographic view after treatment.
